HOTEL FIRE
Las Vegas, NV
February 10, 1981

Fire Investigation Report

**Hotel Fire
Las Vegas, Nevada
Eight Fatalities
February 10, 1981**

**David P. Demers, P.E.,
Consultant to
NFPA Fire Investigations Department**

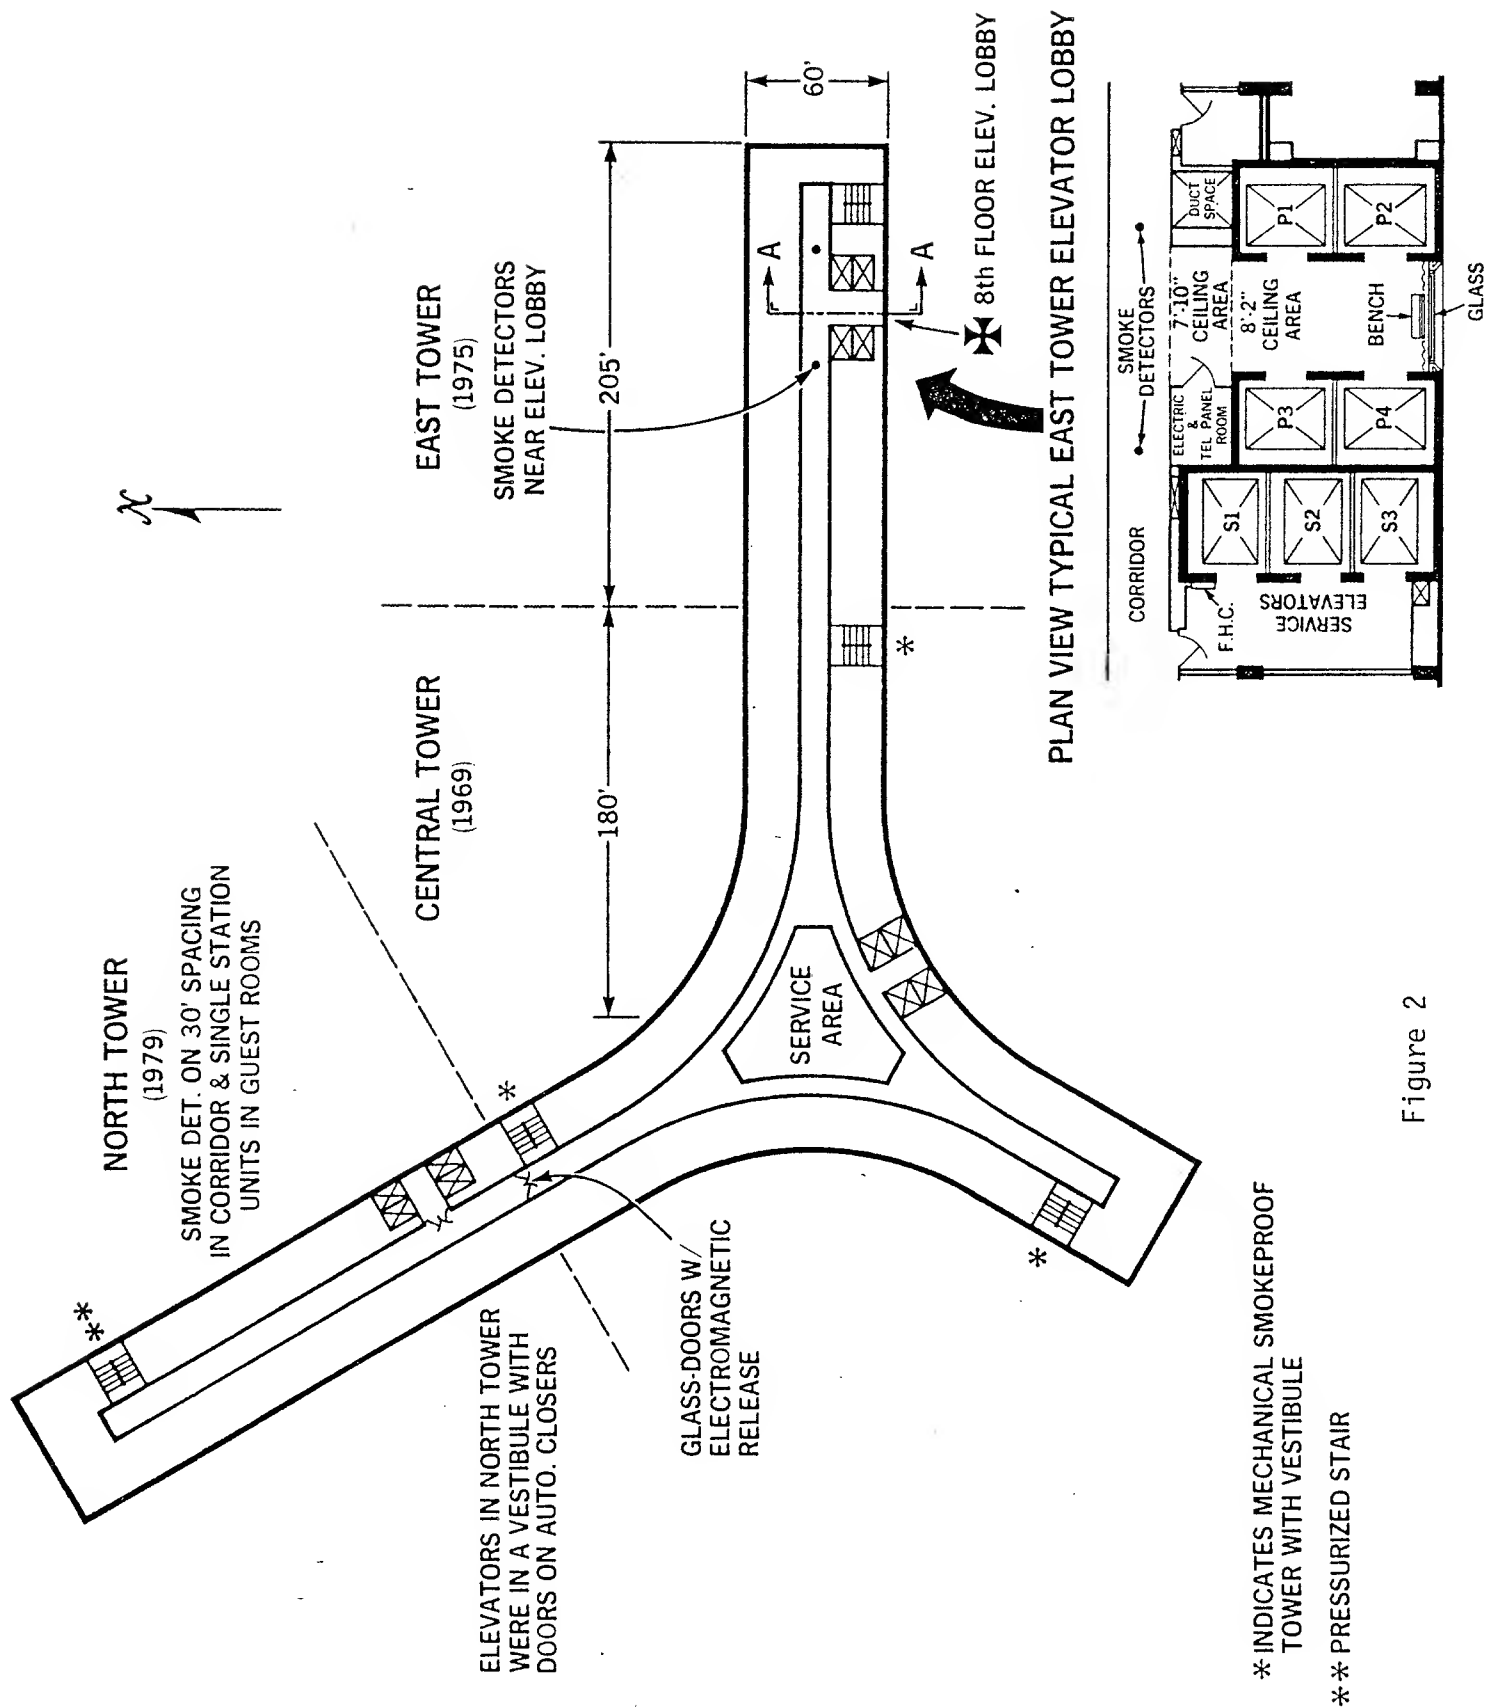
Figure 2

The 30-story building was constructed in three stages. The original Central Tower was started in 1967 and opened in July of 1969. The East Tower opened in 1975 and the North Tower opened in 1979. This resulted in different provisions for fire safety in each of the three towers due to differences in building code requirements, technology, and construction techniques (see Figures 1 and 2).

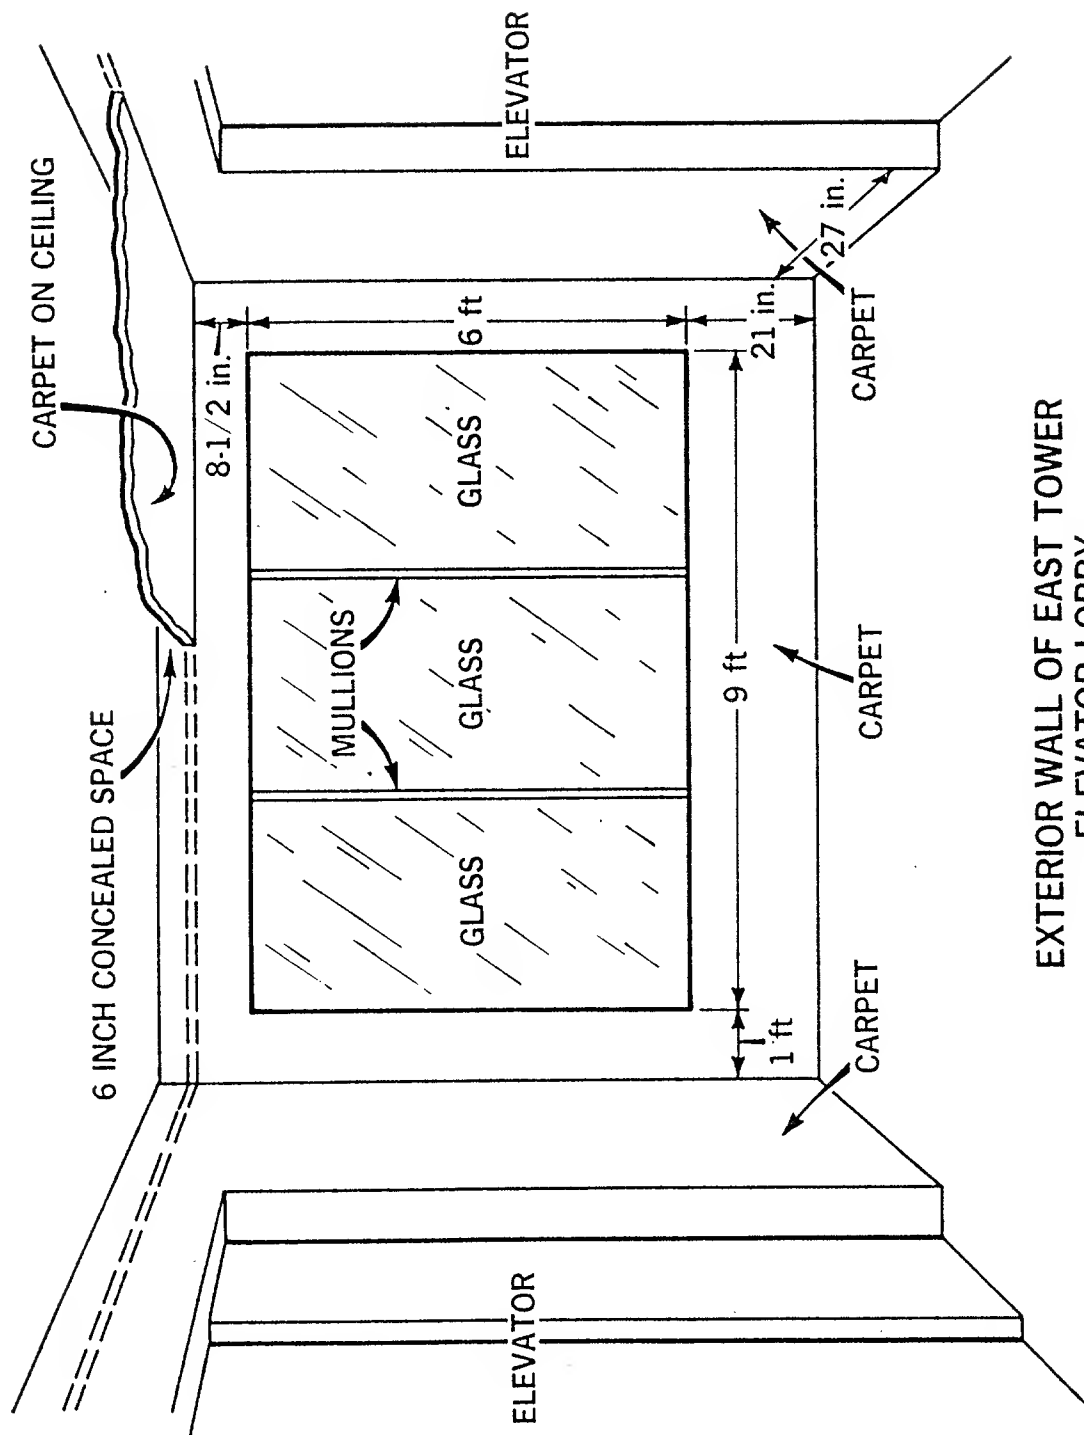
Figure 3

The East Tower elevator lobbies had four elevators; there were two on each side. Each pair was in an individual hoistway. On the exterior wall, there were three 3-foot by 6-foot double strength plate glass windows, creating a large glass area 6 feet by 9 feet (see Figure 3). The lights of glass were recessed 18 inches and were separated vertically by a 3 1/2-foot spandrel (see Figure 1).

The spandrel was a prefabricated masonry, plaster and gypsum wallboard on steel stud assembly. There was no apparent evidence of any combustible material, such as foam plastic insulation, associated with the assembly. This spandrel unit was attached to the reinforced concrete building structure. The type of caulking used was undetermined.

EXTERIOR WALL OF EAST TOWER
ELEVATOR LOBBY
LAS VEGAS HILTON
